National Dam Safety Program. Big Spring Dam (NDS I.D.-461), Ohio River Basin, Big Spring Run, Westmoreland County, Pennsylvania. Phase I Inspection Report.

PHASE I INSPECTION REPORT
NATIONAL DAM INSPECTION PROGRAM

BIG SPRING DAM
NDS I.D. NO. 461
APRIL 26, 1978

PHASE I REPORT
NATIONAL DAM INSPECTION PROGRAM
BIG SPRING DAM
NDS I.D. No. 461

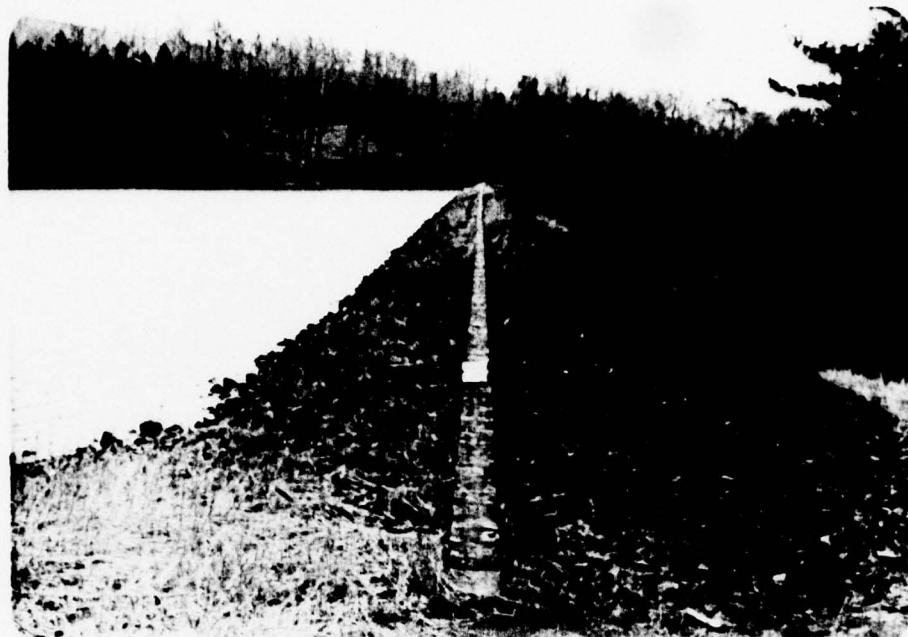
Photograph No. 1
Crest (looking west).

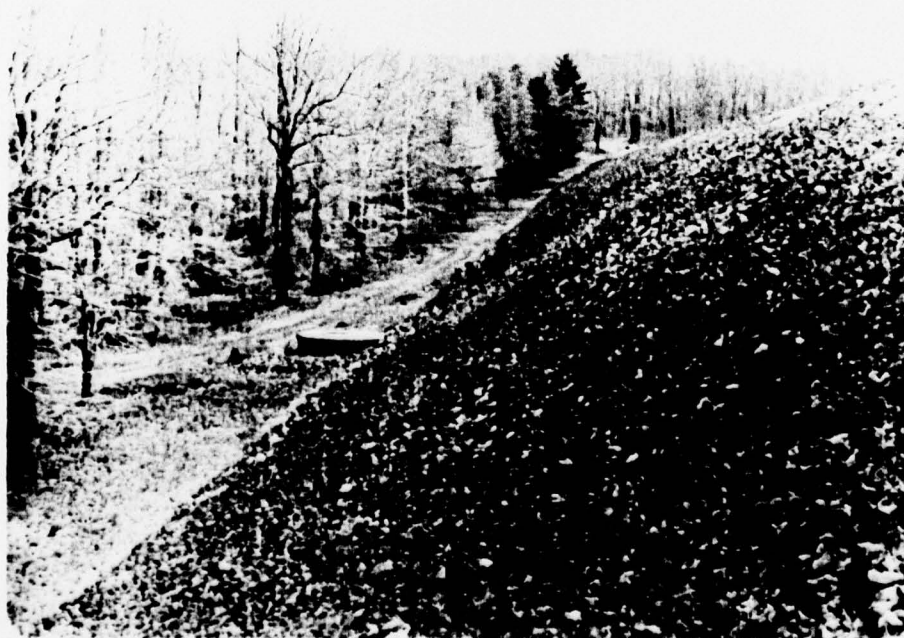
Photograph No. 2
Downstream slope (looking east). Note gate chamber in
middle of photograph.

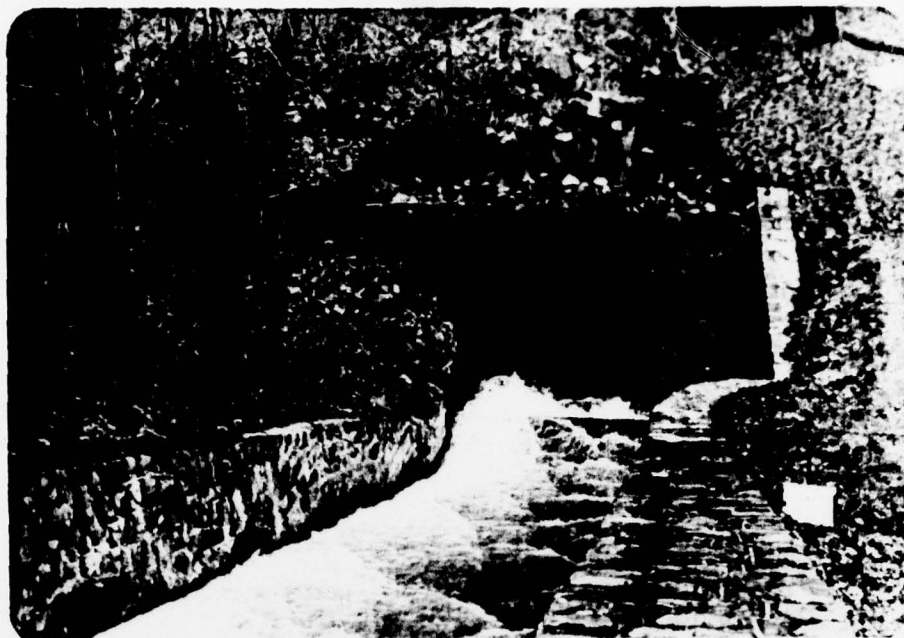
c. Appurtenant Structures. The spillway structures, spillway crests, channels, and plunge pools were examined for deterioration or other signs of distress and obstructions that would limit flow. In general, the structures were found to be in good condition. The plunge pool was examined and scouring and erosion were observed (Photograph 5).

Photograph No. 5
Spillway plunge pool (note erosion).

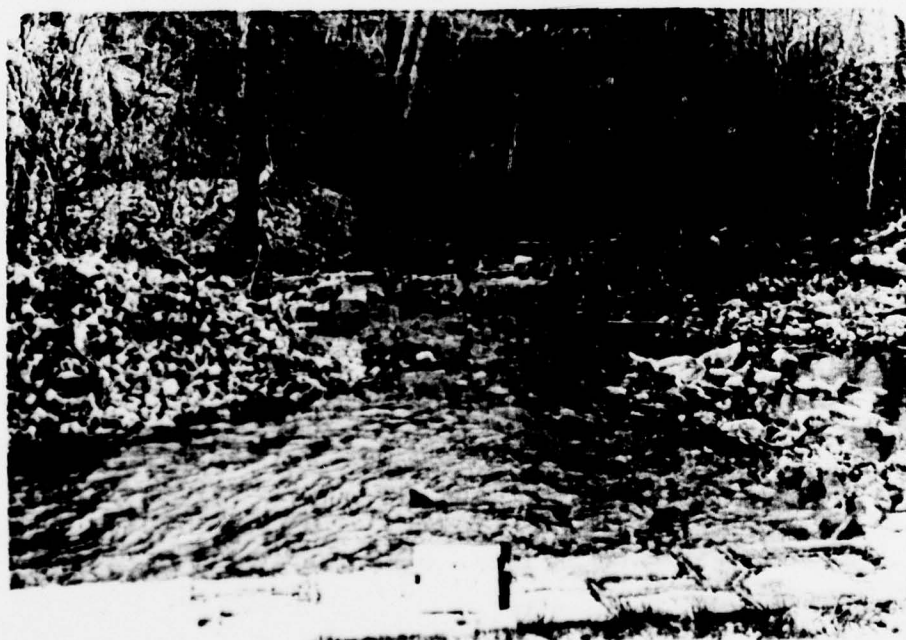
Photograph No. 6
Stream channel downstream of plunge pool.

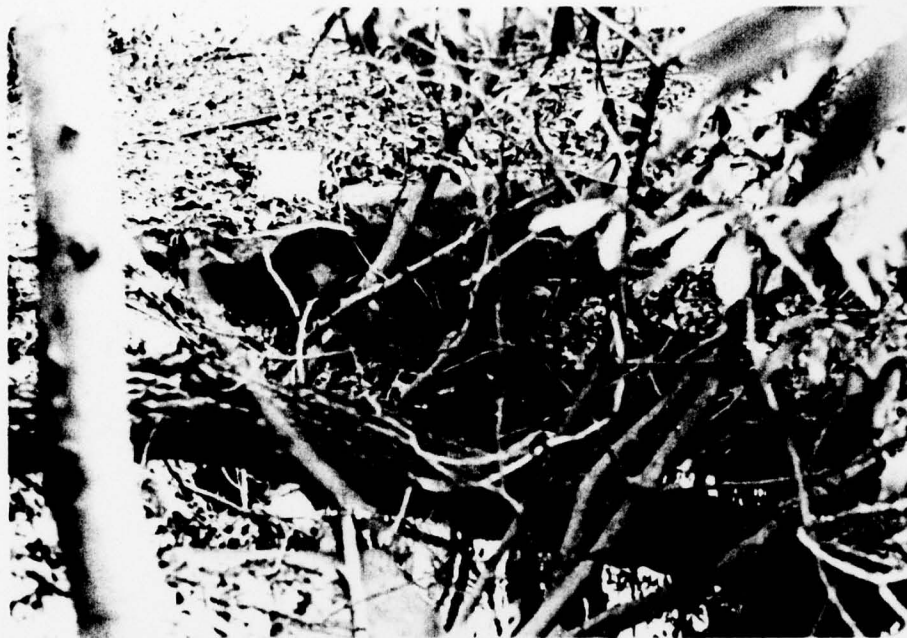
1. Two wet areas were observed at the toe of the dam (Plate 5): one to the right of the spillway channel and another to the right of the center of the embankment. No perceivable seepage was associated with these wet areas.
2. Minor seepage was observed on the left abutment draining into the streambed approximately 50 feet downstream of the plunge pool.
3. The outlet channel of the "blow-off" pipe was noted to be partially obstructed with fallen trees and other debris.

Photograph No. 7
Outlet end of "blow-off" pipe.

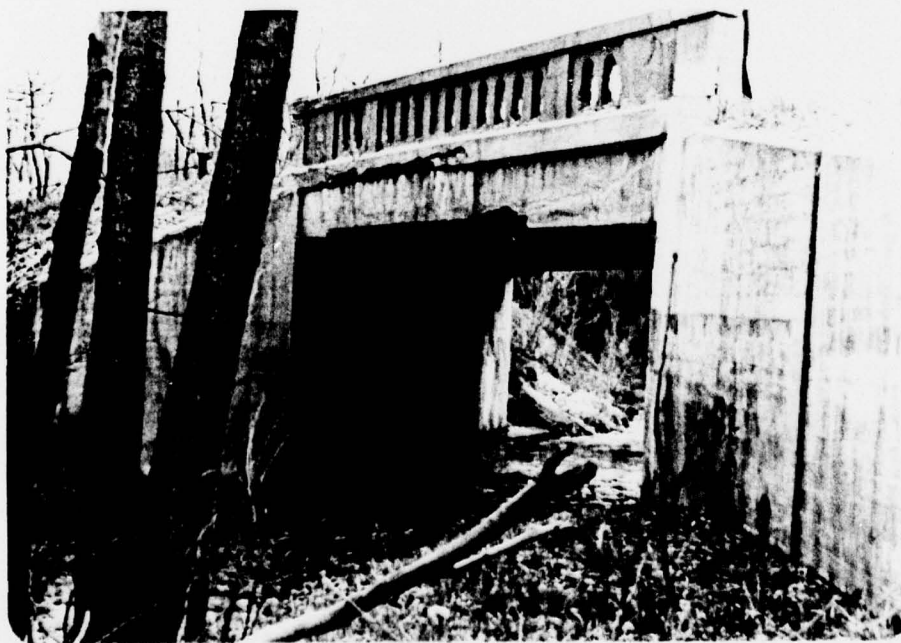
Photograph No. 8
Bridge on Route 711 (Bridge No. 1).
